Role of Starting Material Composition in Interfacial Damage Morphology of Hafnia Silica Multilayer Coatings

This paper was prepared for submittal to the
30th Boulder Damage Symposium: Annual Symposium on
Optical Materials for High Power Lasers
Boulder, Colorado
September 28 - October 1, 1997

Role of starting material composition in interfacial damage morphology of hafnia silica multilayer coatings

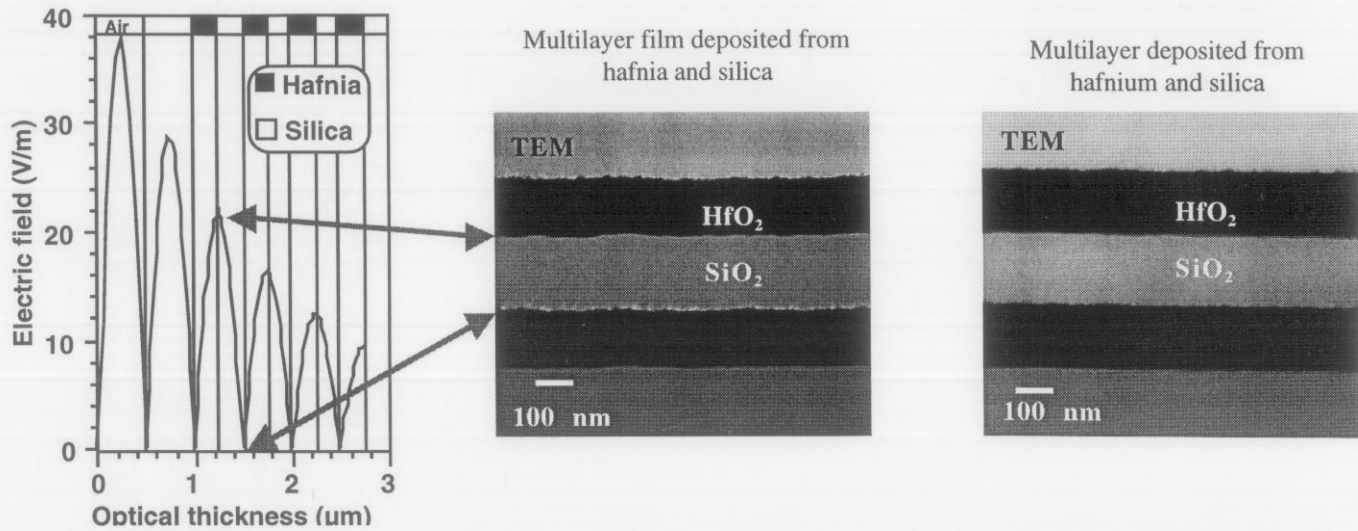
Fig.1 Comparison of interface quality as a function of starting material composition and corresponding electric-field profile.

being stronger. Interestingly, for the hafnia deposited coatings, the opposite interface appears be stronger based on the amount of interfacial voiding illustrated in figure 1. If this experiment would be repeated with hafnia deposited coatings, they would likely have shallow flat bottom pits with depths one or three layers corresponding to the electric field peaks, but at the opposite interface of the hafnium deposited coatings.

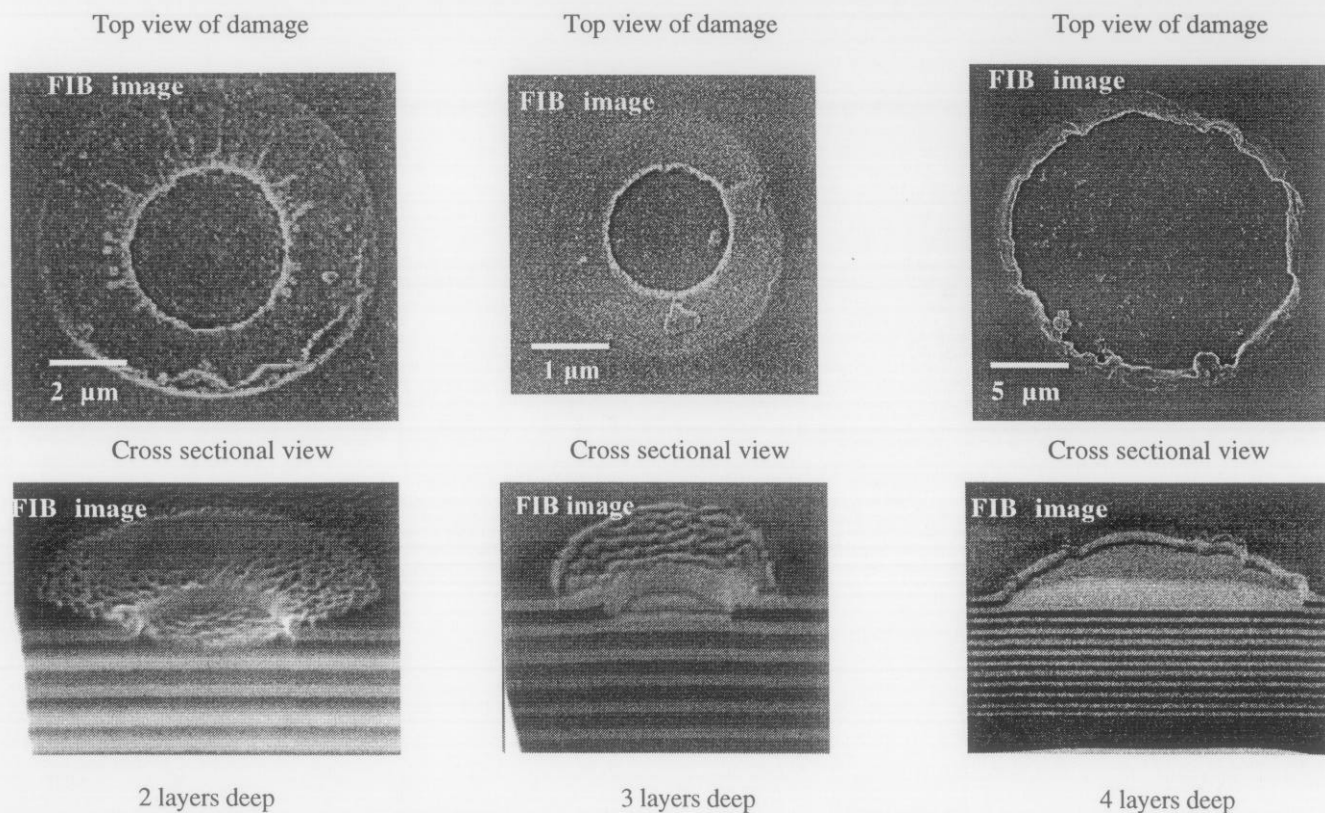
Coatings deposited from hafnia and silica have a significant number of flat bottom pits at various interfacial depths as shown in the FIB micrographs in figure 3. These samples were irradiated at 30 J/cm² at 10 ns, which correlates to 20 J/cm² at 3 ns assuming a pulse length scaling relation of $\tau^{0.35}$. Similar morphologies are also reported for measurements at 3 ns.²⁻³ The

Fig. 3 Flat bottom pits are interfacial damage that usually occurs in the outermost layers.

Typically the damage is one to three layer pairs deep corresponding to the interfaces at electric field peaks. However, there are exceptions such as the three layer deep pit in figure 3. This is particularly troublesome to explain by the theory of nanoscale absorbing seeds at high electric field locations since the damaged interface is at an electric field minimum. The two layer deep flat bottom pit shows evidence of plasma interaction throughout the entire pit by temperature-induced surface roughening typical of plasma scalds. However the bottom of the three and four layer deep flat bottom pits are smooth indicating a mechanical failure of the damaged layer possibly after the plasma extinguishes when the film rapidly goes into tension during cooling. This delamination mechanism has also been observed in the outer layer of coatings with thin overcoats.¹¹ Although the damage may be initiated by nanoscale absorbing seeds at high electric field locations, the interfacial quality and plasma presence may also play critical roles in the ultimate flat bottom pit depth.

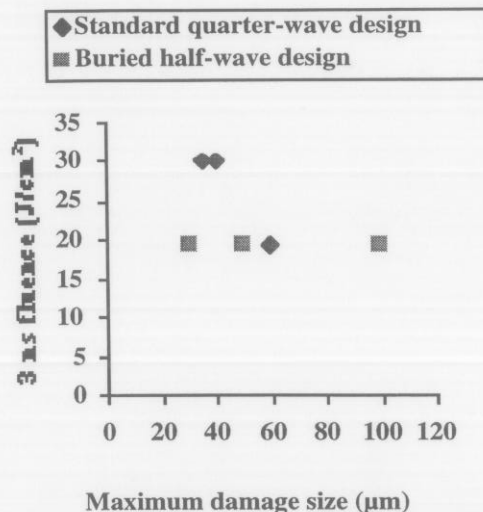
As illustrated in figure 4, the buried half-wave coatings typically have larger damage sites for a given fluence and catastrophic sites at a lower fluence than the all quarter-wave coatings. For the buried-half wave samples, most were raster-scanned at increasing fluences until approximately 20 J/cm² before testing was stopped due to damage. The all quarter-wave coatings

Fig. 4 Damage in all quarter-wave coating was smaller at higher fluences than the buried half-wave coating.

were raster scanned at increasing fluences until approximately 30 J/cm^2 before testing was stopped. It is not surprising that the buried half-wave coatings had a lower damage threshold because the maximum electric field peak is more than twice that in the all quarter-wave design.

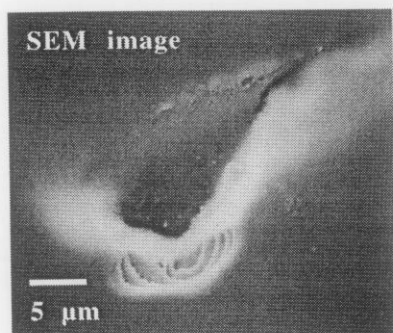
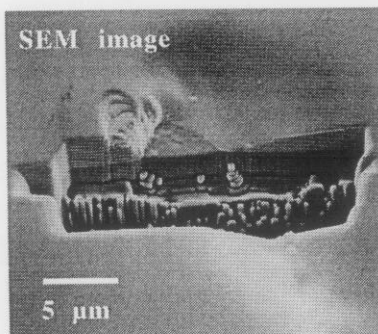
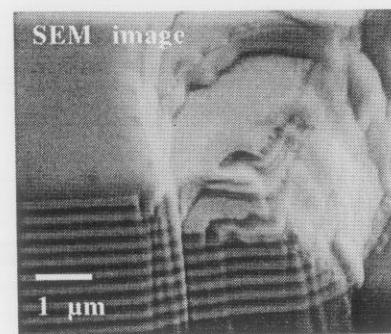
Top view of damage morphology.

FIB cross section of damage site reveals substrate interfacial damage.

Multilayer interfacial damage likely due to nonuniform adhesion between defect and coating.

Fig. 5 Damage morphology of site 1 of all quarter-wave reflector has substrate interfacial damage.

The interfacial damage that occurred in the all quarter-wave design is shown in figures 5 and 6. In each case the damage occurs at the substrate multilayer interface as revealed in the FIB cross sections. Previous cross sections have revealed that critical nodular defects are at or near the substrate interface, so these damage sites may have been of nodular origin. The damage illustrated in figure 6 was first noted at approximately 15 J/cm^2 , but unfortunately was not examined for depth. This allows for two possible explanations for the damage morphology. First, the original formation of the pit could have been shallower, making the damage a result of the electric field that then grew to its final depth. However, if the pit stayed at its original depth of about $3.5 \text{ }\mu\text{m}$, the electric field peak should not be a factor in the damage, therefore a different mechanism may be responsible for multilayer substrate interfacial damage. Other damage morphologies were also found, mainly plasma scalding and nodular ejection that are stable at fluences up to 30 J/cm^2 .

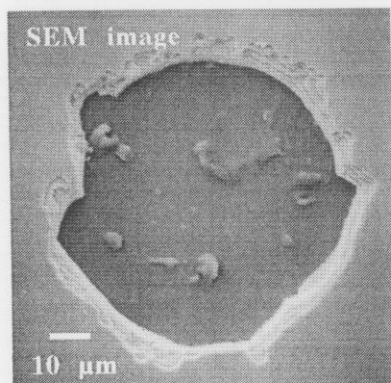
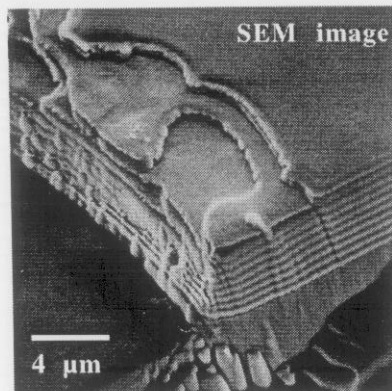
Top view of damage morphology

FIB cross section reveals substrate damage

Fig. 6 Damage morphology of site 2 of all quarter-wave reflector has substrate interfacial damage.

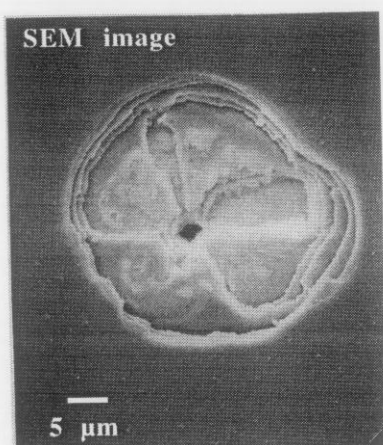
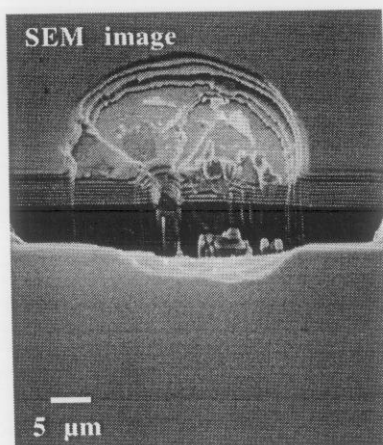
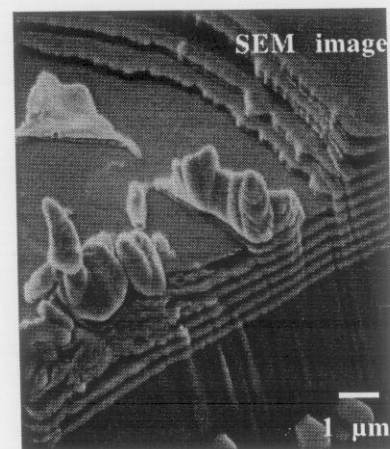
The interfacial damage in the buried half-wave design, as illustrated in figures 7 and 8, are very different than the all quarter-wave design and look more like typical flat bottom pits with the exception of the pit depth. In these damage sites the pit was six to ten layers deep and appeared to be initiated at a nodular seed. In contrast, hafnia deposited all quarter-wave design coatings typically have flat bottom pit damage that is much shallower at two to six layers deep.

Top view of damage morphology

FIB cross section reveals damage likely originated from a nodular ejection

Interfacial damage is 6, 8, & 10 layers deep

Fig. 7 Damage morphology of site 1 of buried half-wave design has multilayer interfacial damage

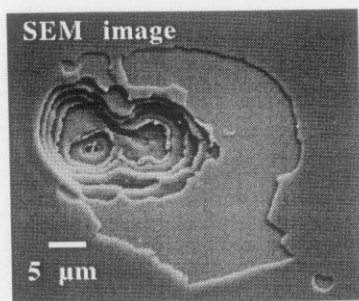
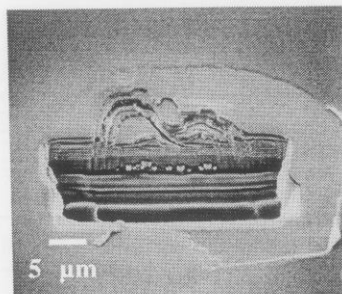
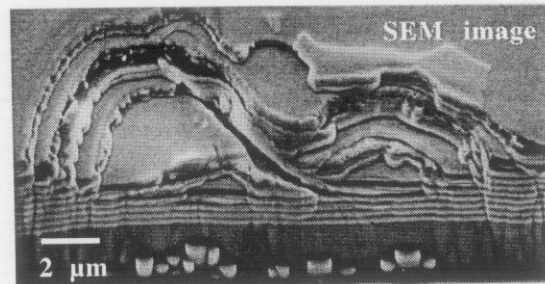
Fig. 8 Damage morphology of site 2 of buried half-wave design has multilayer interfacial damage.

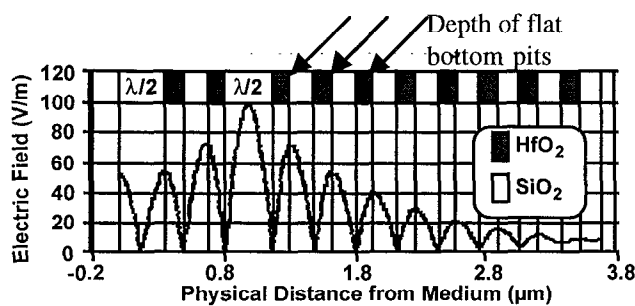
Inspection of the electric-field profile, illustrated in figure 9, confirms that the damage depth correlated to interfaces at electric field peaks. Although there were electric field peaks of similar magnitude closer to the surface, flat bottom pits did not occur at these depths. This result suggests a difference in the strength of the two types of interfaces with the silica grown on hafnia

Fig. 9 Flat bottom pits correlate to the hafnia over silica interfaces with electric field peaks.
